# Findings Vidanta/Cirque Du Soleil Power Issues

Tyrone J. Mellon Jr, MBA, MSEE  
Director of Engineering – Lex Products  
15 Progress Drive  
Shelton, CT, 06492, USA

**Abstract—** The power system for the venue housing the Cirque Du Soleil performance Joya is reporting power quality issues that are compromising the ability of the show to operate as intended. The sizing of the UPS devices in the system appears to be insufficient for the connected loads. Current measurements on site should be used to confirm the issue and right size UPS system to work with the connected loads and show cues. The issues with the automation system are intermittent and warrant further investigation.

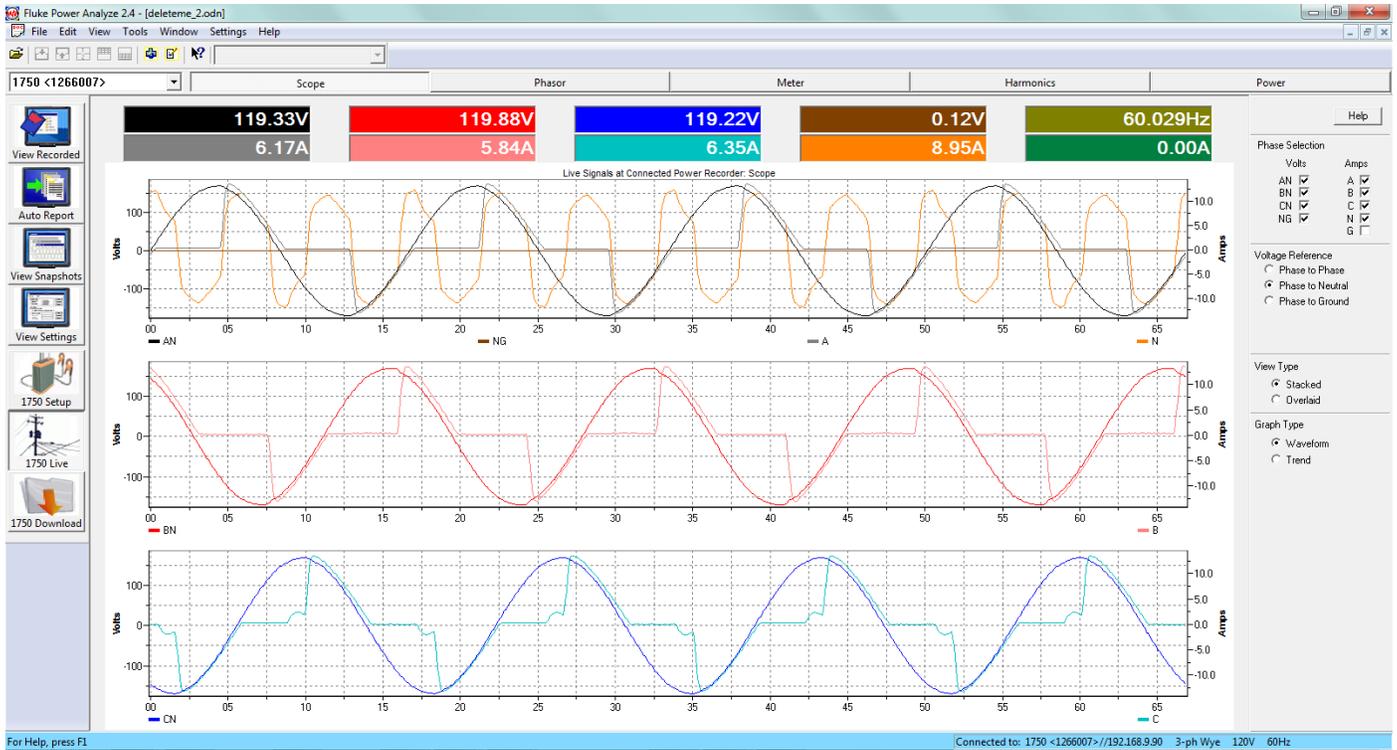
In comparison, non-linear load currents tend to add on the neutral conductor resulting in larger currents on the neutral than would be present on any one phase conductor which can result in neutral currents in excess of the phase currents in the system. With lighting loads dimmed to 40-60% on all three phases, the neutral current in the system can reach 130% or more than that of the individual phase conductors. The monitoring software SNMPView is only reporting the most loaded phase while the UPS email warning system is taking into consideration the load on the neutral conductor as well, explaining why the UPS is reporting errors when the conventional lighting set up is at 45% of load with most lamps dimmed.

To demonstrate the larger neutral currents, a simplified circuit in Lex Products laboratory was setup up with 3 dimmers dimmed approximately to 50% each connected between one of the phases and neutral to illustrate the increased current on the neutral over that on any one phase. In this circuit, the neutral current was approximately 140% of the phase currents, see Table I, and Figure 2 (next page).

Fig. 2. Screenshot of Data from Table I

**Option 1:** To change the UPS to match the capacity, the neutral currents will need to be measured during a run through of the lighting cues for the show to determine peak current and UPS size. Network power loggers from a variety of companies may be used. Lex Products can recommend a specific model if needed.

After determining the largest neutral current present, the UPS size needed is best determined by working with the UPS manufacturer. An approximation of what size UPS can be estimated by using the below formula where  $I_n$  is the neutral current,  $V_{ln}$  is the nominal voltage between line and neutral.

$$KVA \text{ Rating of UPS Needed} = I_n * 3 * V_{Ln} * 1.25$$
